ORNL-5039
UC-41-Health and Safety

EXPEDIENT SHELTER CONSTRUCTION AND
OCCUPANCY EXPERIMENTS

Cresson H. Kearny

MARCH 1976

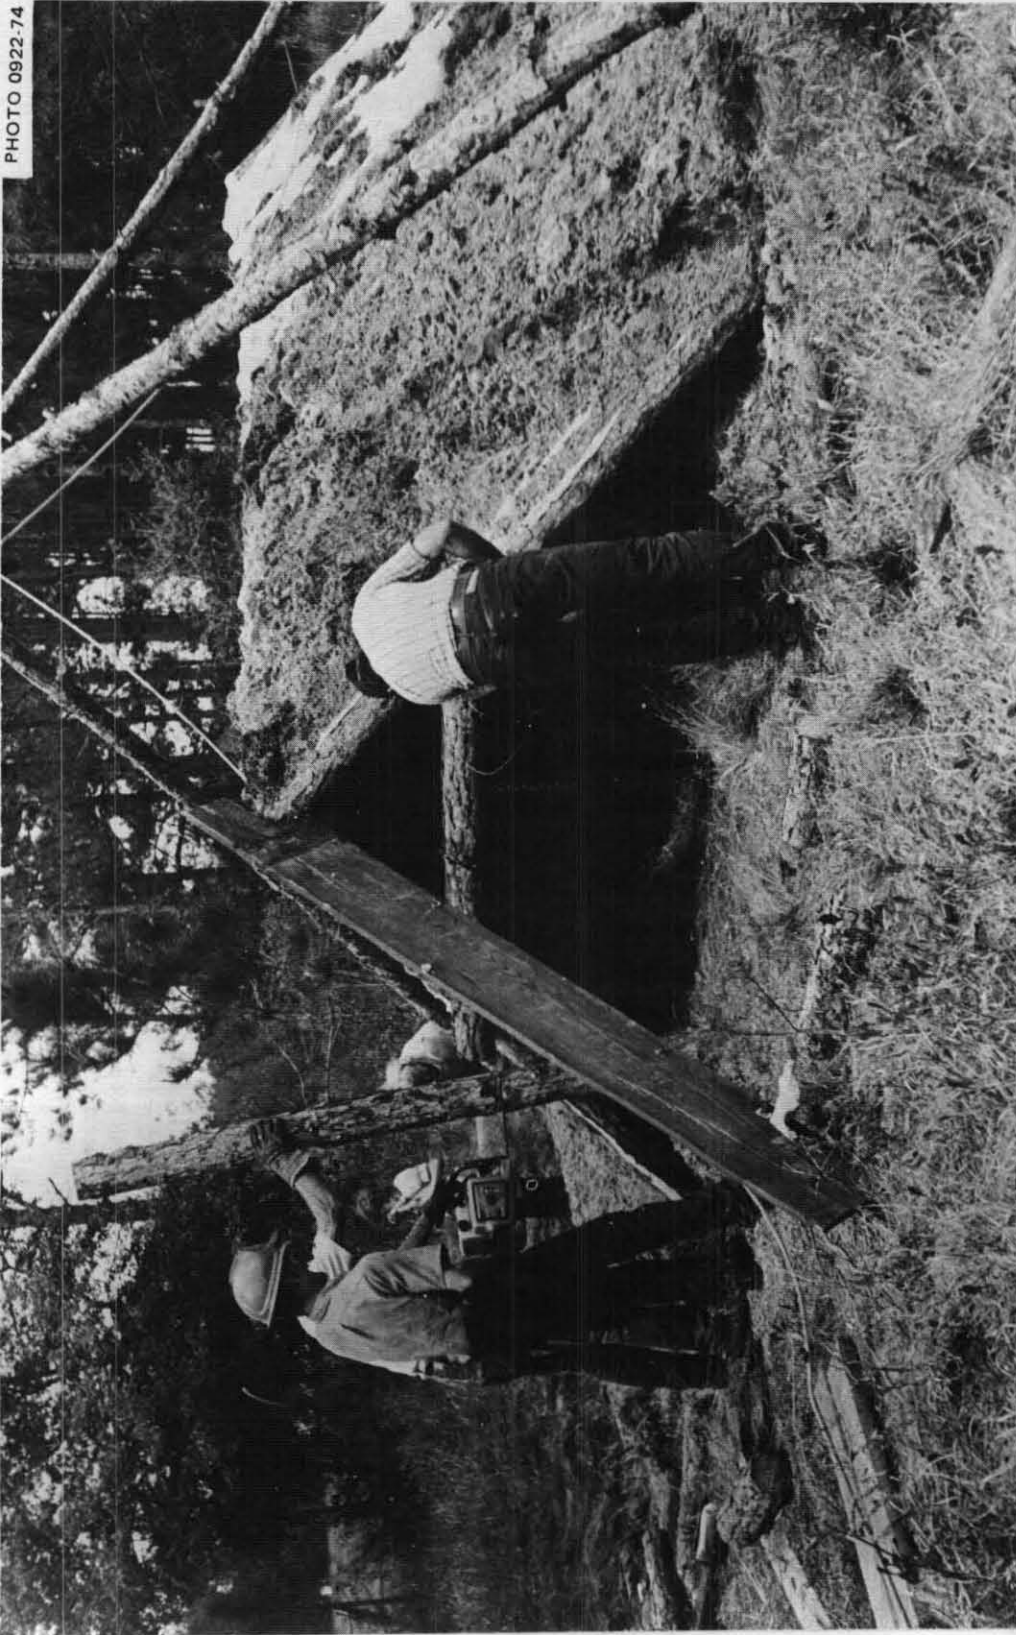
Fig. 5.49. Unnecessary work and delay resulted because these families failed to follow some of the instructions, especially as regards placing earth on the shelter starting from ground level and working upward. While Kearny was going to his car to get some food (the mud prevented his driving his station wagon to this site), the ridge of this shelter shifted lengthwise about 4 in. The builders stopped this move with the board brace pictured and then pulled the whole shelter back into its correct position with a chain and powerful hand-operated winch.

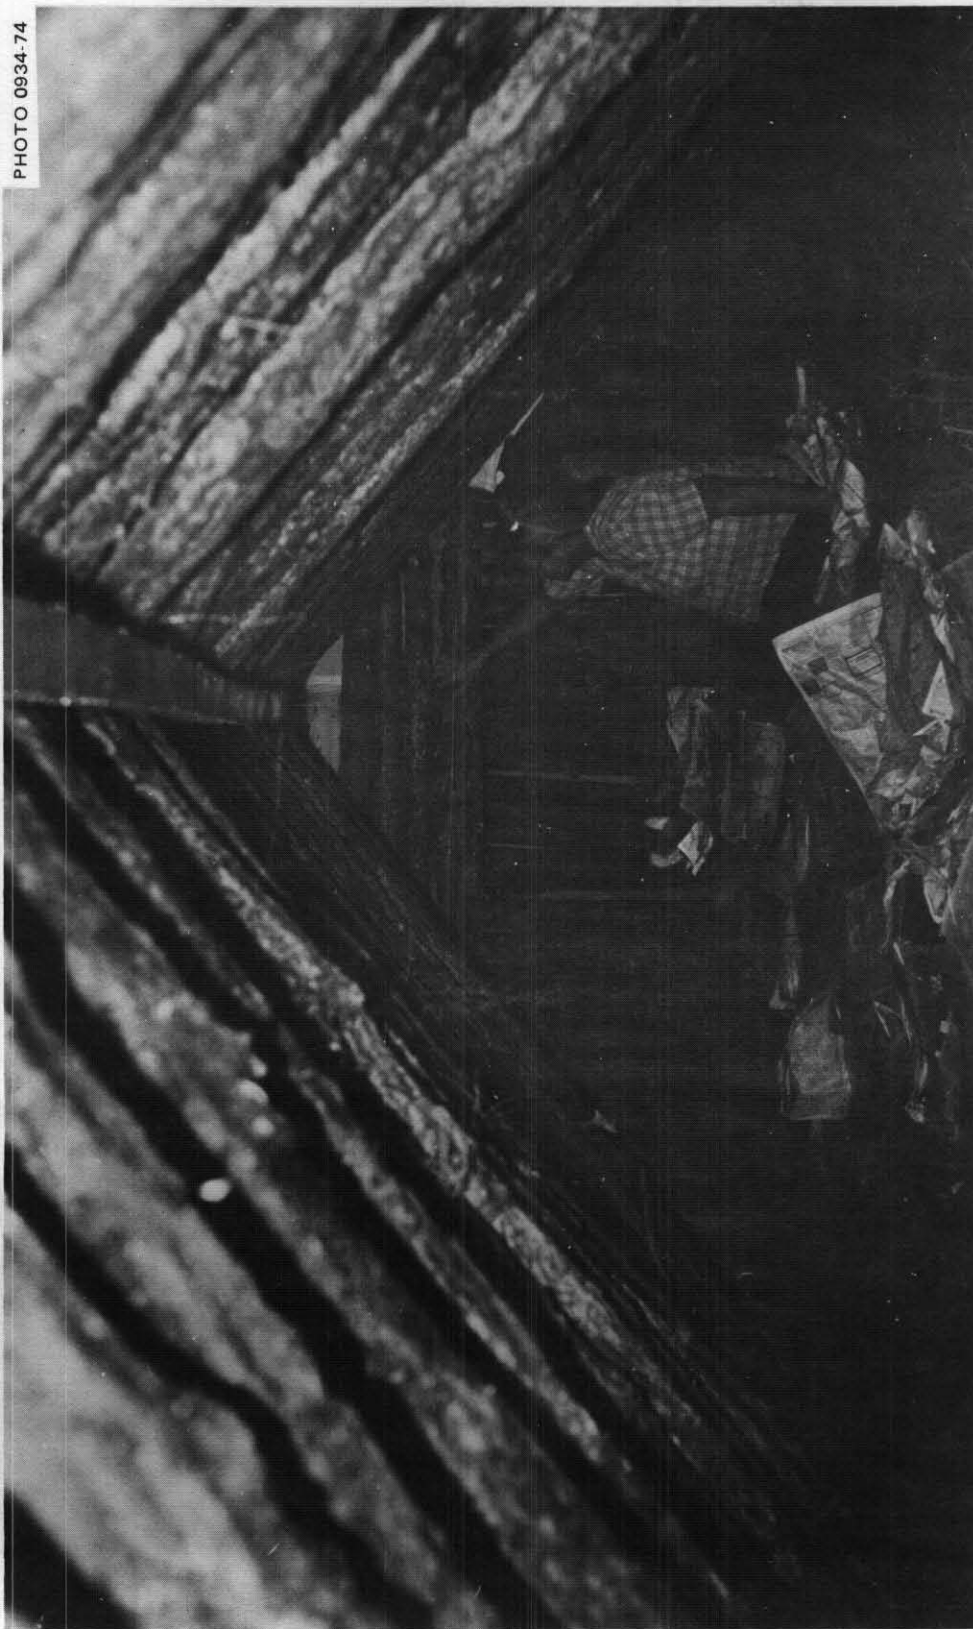
Fig. 5.53. Entrance of the A-Frame Pole Shelter which had a main room 21 ft long and 13 ft wide. It rated a 21-person shelter (as Kearny rated this shelter), this gives each person 13 sq ft of floor space. Both builders and civil defense officials who inspected these shelters agreed that people could get by with 10 sq ft per person of floor space, even though the roof was low and sloping.

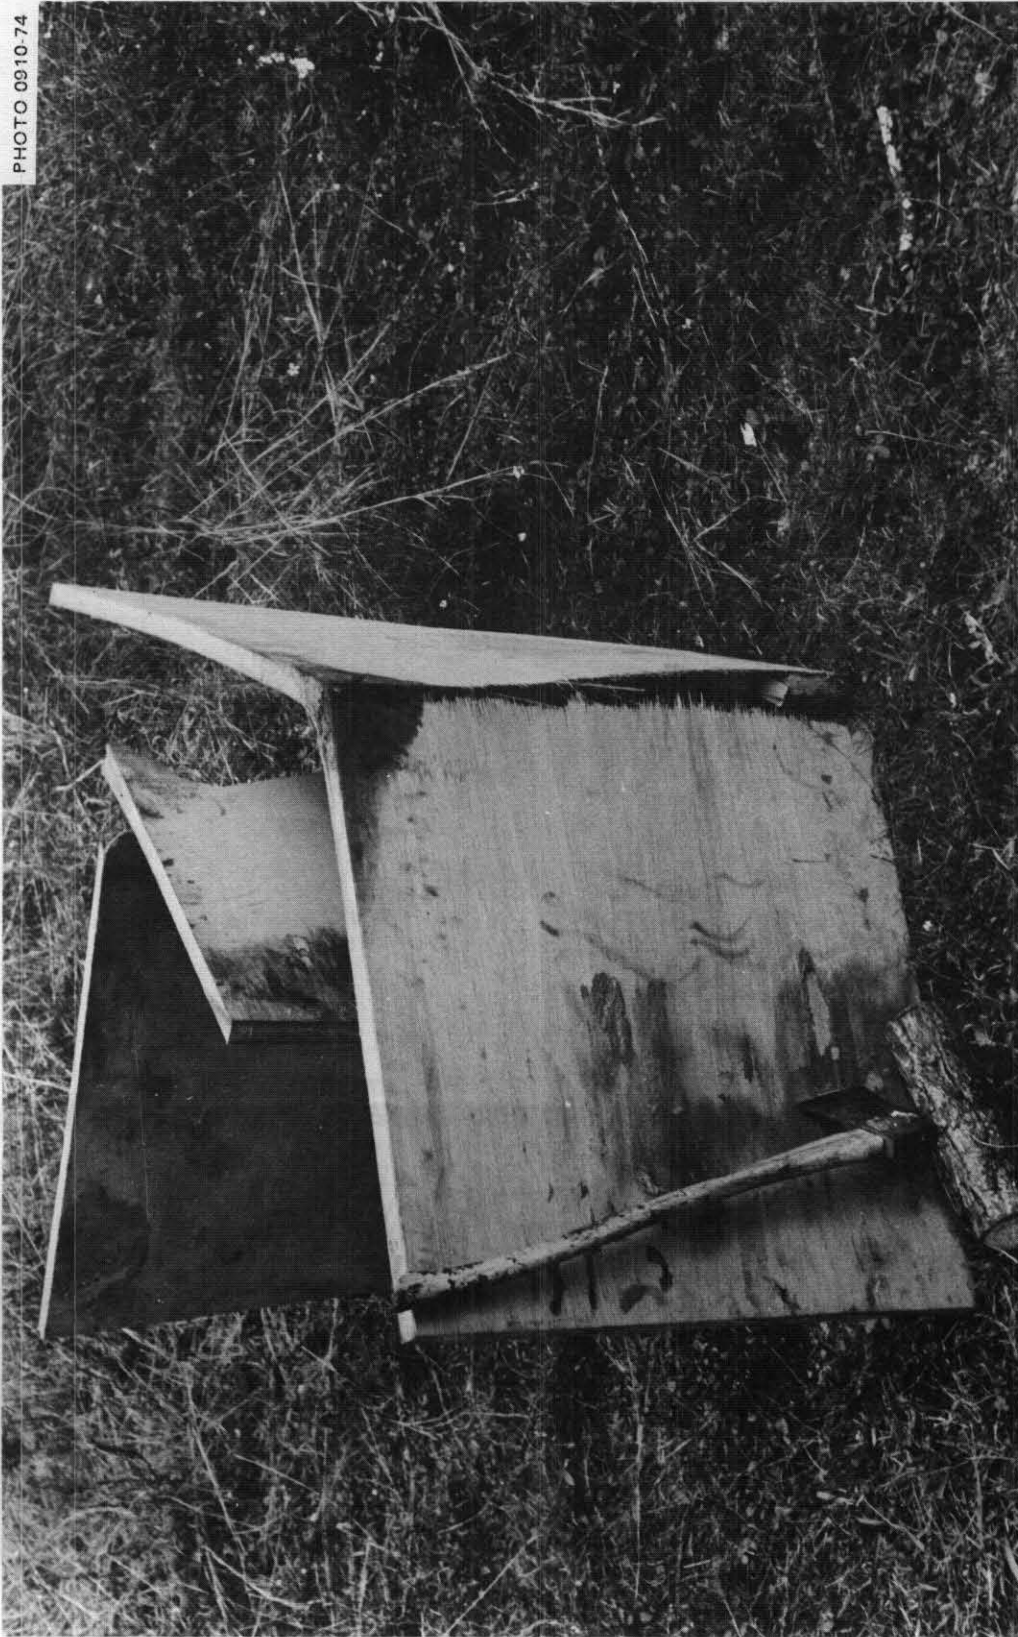
Fig. 5.56. Two of the broken roof doors after they were moved from the previously described shelter. Because the ratio of the depth of earth cover over these doors to the width of free span was too small, the centers of these broken doors fell to the floor of the shelter.

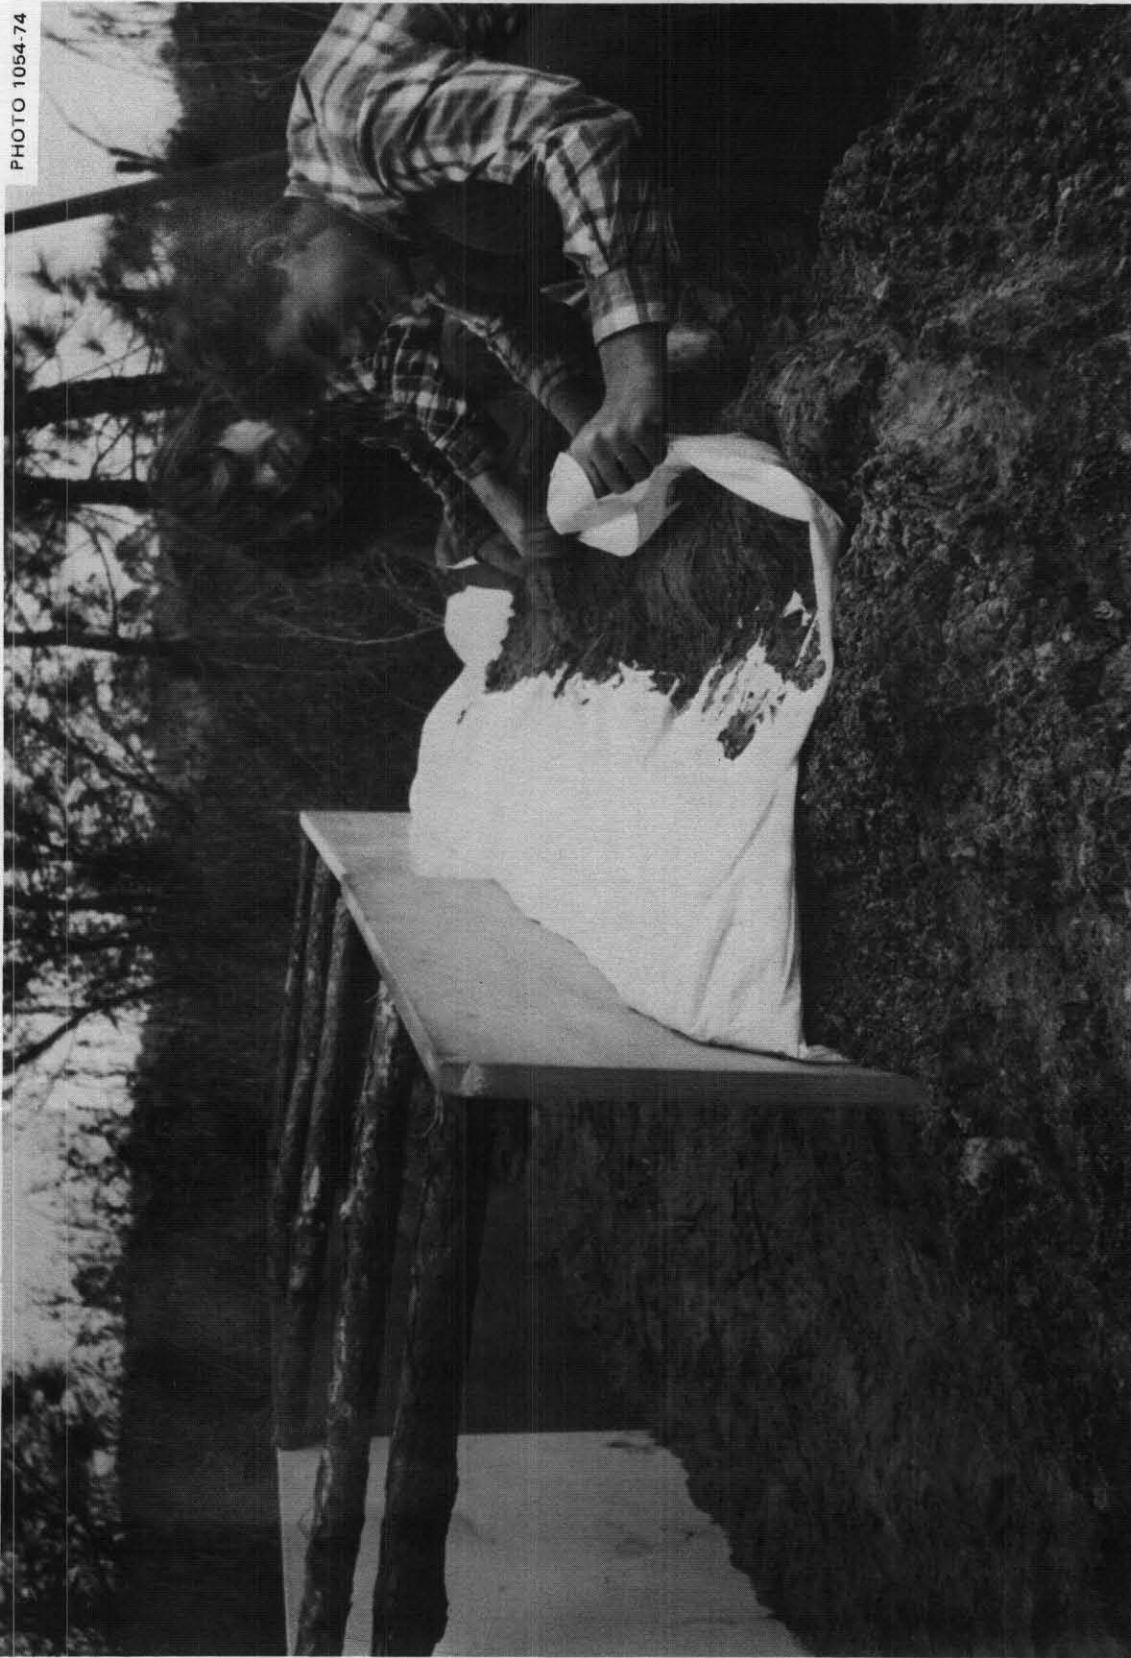
Fig. 5.58. Workmen building the first prototype of a shelter with vertical interior walls consisting of 2 or 3 rolls, stacked one on top of the other. This photo shows the workers forming an earth-filled "hook," which holds the part of a sheet forming the upper side of a roll in place, so that especially the vertical inner side of the roll will remain in place when the door form is removed.
